Incident Report: Davy Crockett Emergency Response

Update as of July 26, 2011

OPERATIONS UPDATE – July 26, 2011

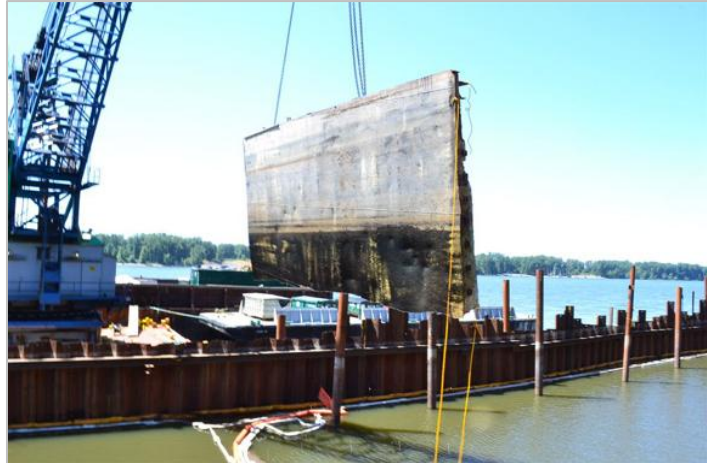
The side shell from the submerged starboard forward deep tank is lifted toward the cleaning barge Umpqua. (7/23/11)

Dive crews on Tuesday, July 26 continued to remove debris from the top of the forward starboard double bottom-tanks and started cutting access hatches to facilitate vessel removal operations. The last remaining submerged sections of the Davy Crockett can be seen in the [July 26 Bow Deconstruction Diagram](#).
